Summary Report on Building Performance

2004 Hurricane Season

FEMA 490 / March 2005

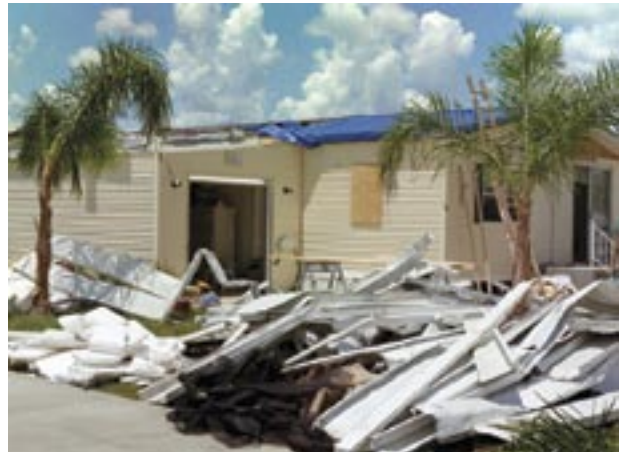
- **Manufactured housing.** Manufactured housing performance was a function of unit age and of the regulations under which they were constructed and installed. In high wind areas, pre-HUD standard homes were mostly destroyed beyond repair. Pre-1994 HUD standard homes performed variably, but the vast majority of these homes located in the path of Charley were damaged significantly even though the wind was less than the current design wind speeds. While post-1994 HUD standard homes performed well structurally, these units sustained damages related to building envelope and accessory structure failures. Improved performance of post-1994 manufactured housing was observed, however the MAT also found widespread damage caused by the failures of improperly designed and constructed attached accessory structures, such as carports and screen rooms. When these attached structures failed, they often tore away siding, roof covering, roof decking, and the exterior walls of the units to which they were connected.

Manufactured housing that had structural damage resulting from accessory structure failure.

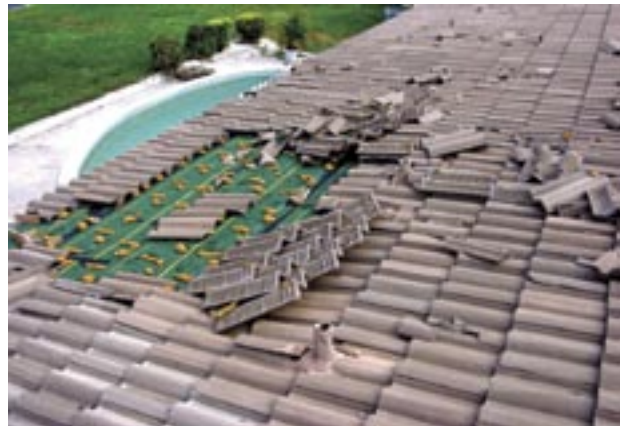
Tiles. Tile roof damage (both clay and concrete) occurred during Charley, Ivan, and Frances, but was most prevalent along the path of Hurricane Charley due in part to the large percentage of homes and buildings with tile roof coverings in Charlotte, Lee, and De Soto Counties. Tile damage from Hurricanes Frances and Ivan was also observed, both of which had much lower recorded wind speeds than Charley. Damage ranged from blow-off of hip and ridge tiles (which was very common even in areas with only moderate wind speeds) to large areas of blown off tiles (which was less common). The tile underlayments generally remained intact so even buildings with significant blow-off areas typically experienced little or no water infiltration from the roof (except in cases where the roof deck failed). Tiles located on ridges, hips, and edges of the roof were frequently a point of failure, especially when they lacked mechanical anchors.

In addition to the damage shown in this photo, this one-story roof lost virtually all of the hip and ridge tiles during Hurricane Charley. (Punta Gorda Isles)

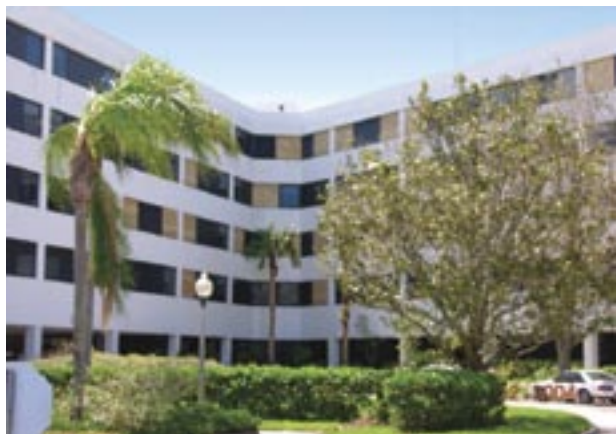
Aggregate from the Indian River Memorial Hospital's roof (Vero Beach) broke several of the patient room windows (which were covered with plywood after Hurricane Frances).

Staff removed loose aggregate from the built-up roofs just prior to Frances' landfall, likely minimizing window breakage and thereby preserving the availability of patient rooms. Additionally, the aggregate surface of a portion of the upper roof had been previously re-roofed in a manner that encapsulated the aggregate, preventing aggregate blow-off.

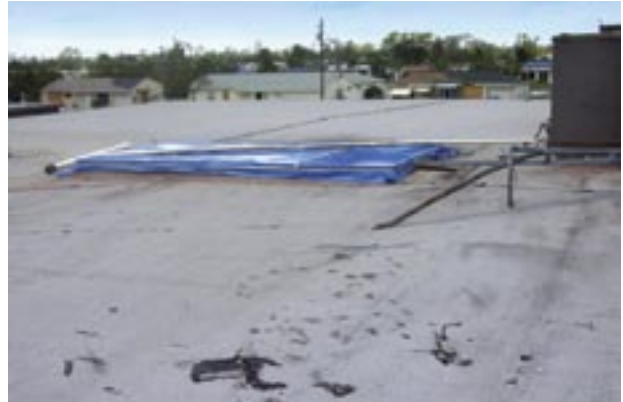
A large HVAC package unit was blown off this curb during Hurricane Charley. Note the loose LPS conductors this side of the curb. This school had significant damage from several pieces of rooftop equipment that blew off the building roof. (Port Charlotte Middle School)

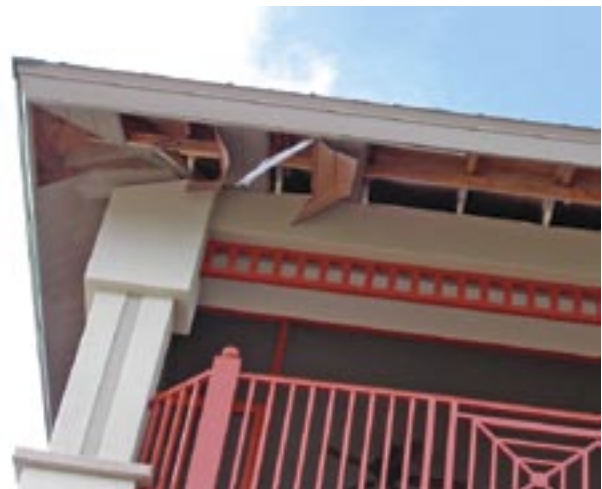
Soffit damage on the third story of a multi-family building. (Captiva Island)

Soffit failure led to many instances of significant damage to building interiors.

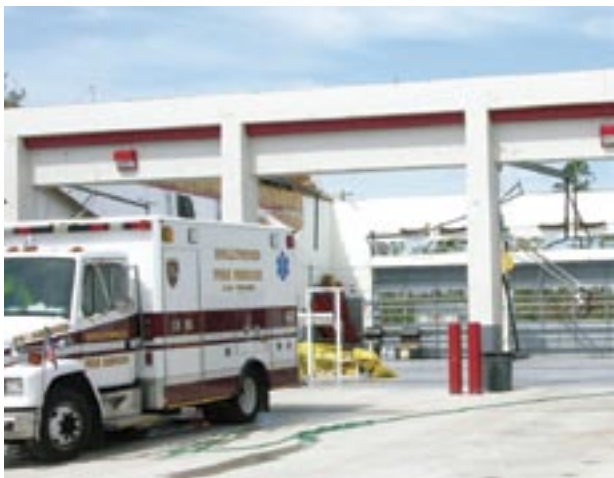
Failure of three of six new doors on a fire station in Charlotte County resulted in the loss of the entire roof structure over the apparatus bay during Hurricane Charley.

more common. Failure of an exterior door has two important effects. First, failure can cause an increase in internal pressure, which may lead to exterior wall, roof, interior partition, ceiling or structural damage. Second, wind can drive rain water through the opening, damaging interior contents and leading to mold development. Interior building damage resulting from door failures is generally preventable if doors and tracks that connect roll up doors to walls are strengthened and reinforced.

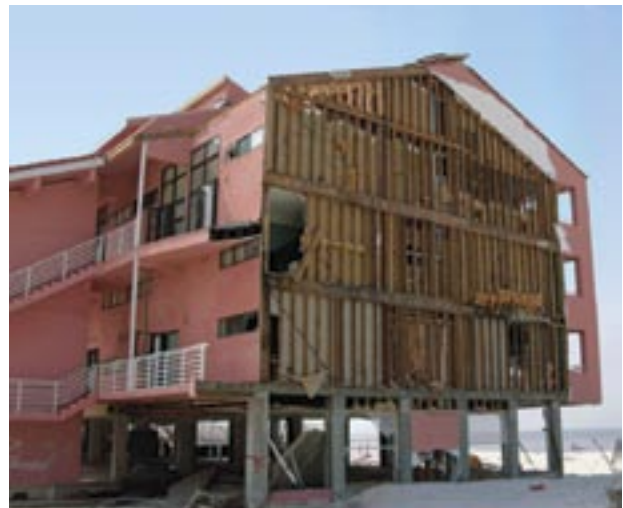
Example of wall cladding failure. The building had synthetic stucco installed over molded, expanded polystyrene insulation and gypsum board. The gypsum board blew off during Hurricane Ivan.

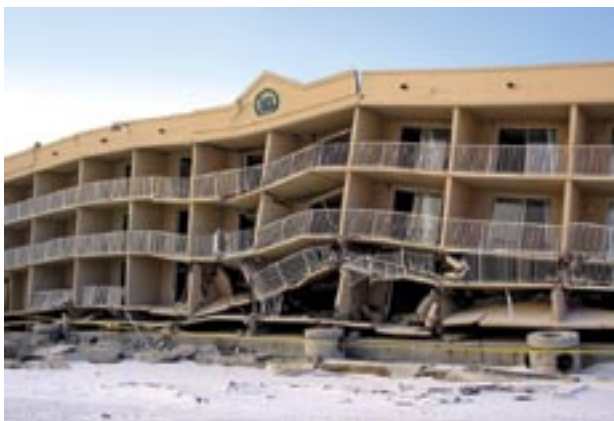
A multi-family condominium collapsed after Hurricane Ivan due to erosion of supporting soil under the shallow foundation.

Several multi-family buildings constructed on shallow foundations in areas along the Gulf coast were severely damaged due to erosion and scour. Many of these buildings were originally constructed in Zones B, C, or X, which did not require deep foundations, but now would require deep foundations if the flood zone was determined from the current methodologies and coastal conditions.

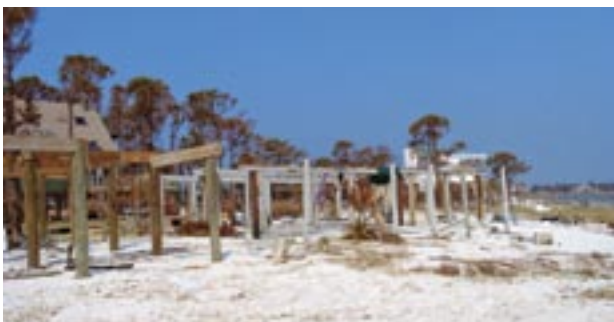
Several structures were completely torn off their pile foundations during Hurricane Ivan as a result of significant flood depths, waterborne debris impacts, and lack of connections.

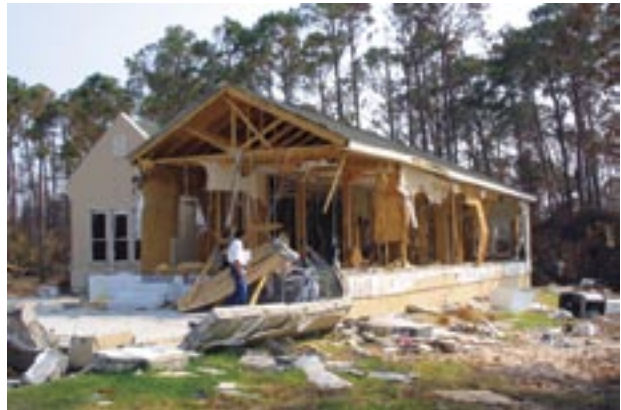
Flood water from Hurricane Ivan exceeded the required elevation of the top of the lowest floor supported by the stem wall foundation for this house leading to severe damage caused by waves and debris impact.

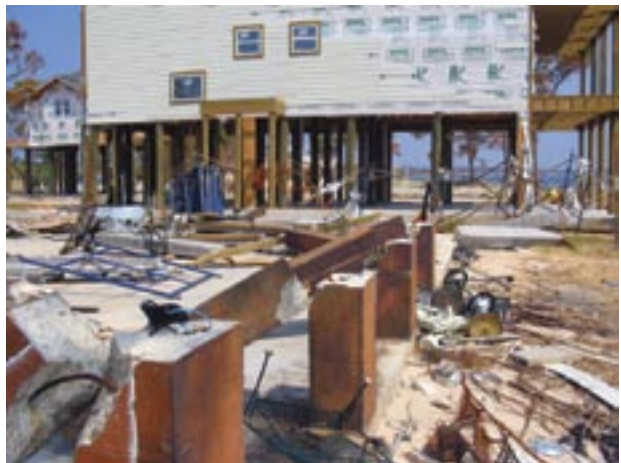
High flood levels during Hurricane Ivan and lack of structural capacity to withstand waves and debris loads caused this reinforced pier foundation to fail.

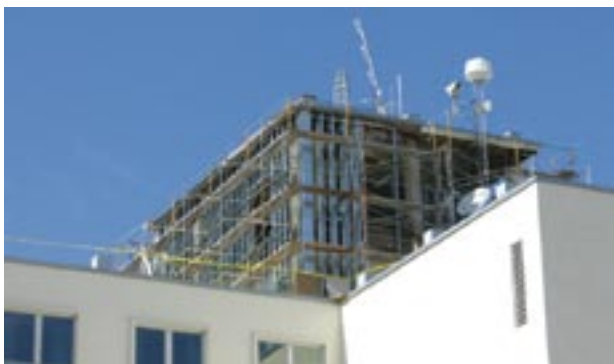
At the Martin Memorial Hospital (Pensacola, Florida) wall panels blew off the elevator penthouse during Hurricane Frances. Rain water entered the elevator equipment room damaging much of the equipment. The falling panels punctured the main roof and at least one of the lower roofs. Because of rain water infiltration and lack of elevator service, floors 2 through 6, which contained 75% of the hospital's beds, were inoperative. Many patients were relocated to other hospitals until the penthouse walls were re-sheathed and new elevator equipment was installed.

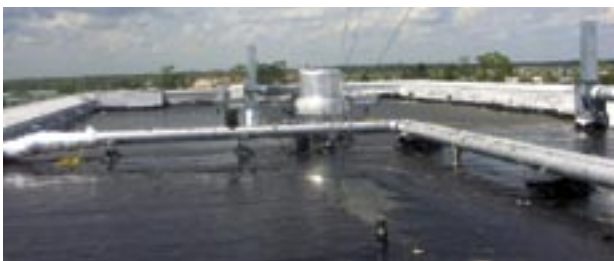
An emergency roof (shown) was installed after Hurricane Charley blew the mechanically attached PVC membrane roof covering off the concrete deck of the Fawcett Memorial Hospital.

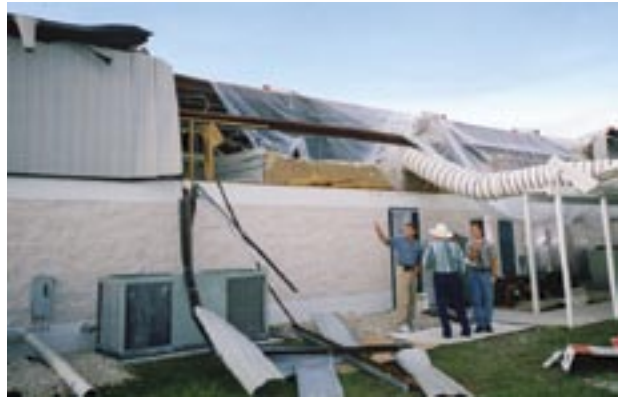
The Charlotte County Sheriff's Office/County EOC, located in a pre-engineered metal building, was significantly damaged and completely taken offline. Despite having openings protected with shutters, the building failed by loss of roof panels (failure of roof clips) and loss of metal wall panels. These failures allowed damaging amounts of rain and debris to enter the facility resulting in closure of the building. The county was aware of the weakness of this facility, and prior to Charley, had begun the design process for a new county EOC facility that would meet statewide Enhanced Hurricane Protection Areas (EHPA) requirements and guidelines not used in the design of the existing structure.

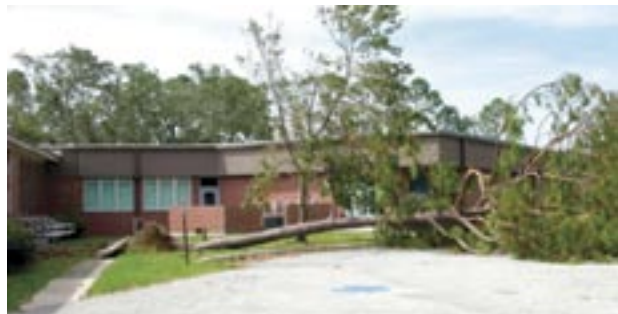
This school building experienced several building envelope problems, which allowed water intrusion, but it did not disrupt operations. Damage and disruptions may have been worse if design wind speed conditions had been experienced.
