Summary Report on Building Performance

2004 Hurricane Season

FEMA 490 / March 2005

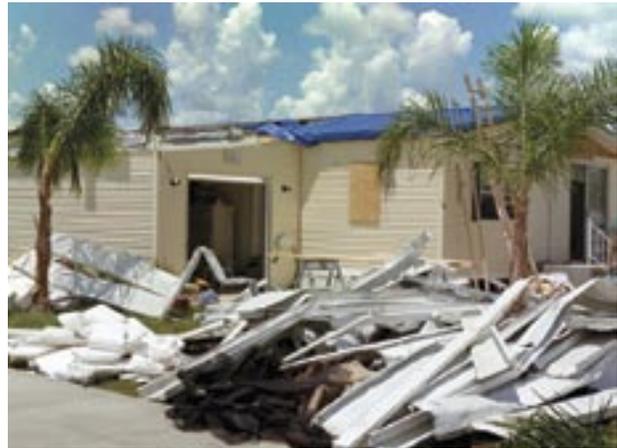
Manufactured housing that had structural damage resulting from accessory structure failure.

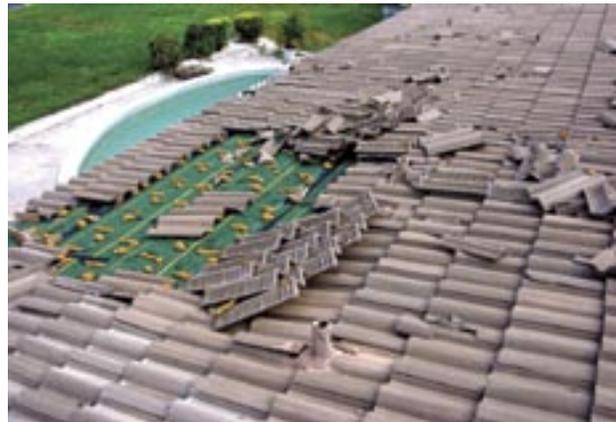
In addition to the damage shown in this photo, this one-story roof lost virtually all of the hip and ridge tiles during Hurricane Charley. (Punta Gorda Isles)

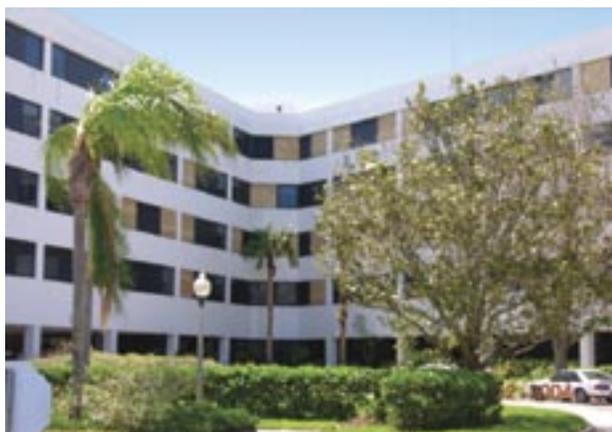
Aggregate from the Indian River Memorial Hospital's roof (Vero Beach) broke several of the patient room windows (which were covered with plywood after Hurricane Frances).

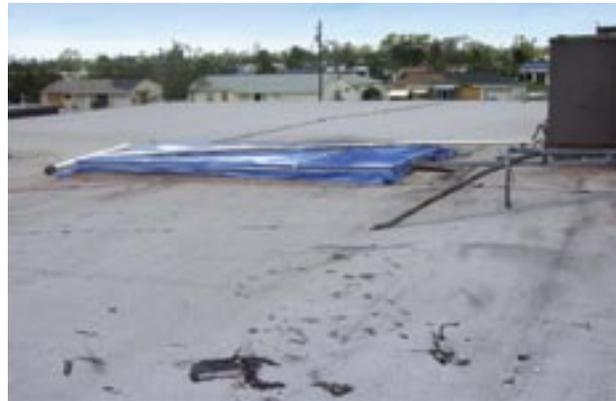
A large HVAC package unit was blown off this curb during Hurricane Charley. Note the loose LPS conductors this side of the curb. This school had significant damage from several pieces of rooftop equipment that blew off the building roof. (Port Charlotte Middle School)

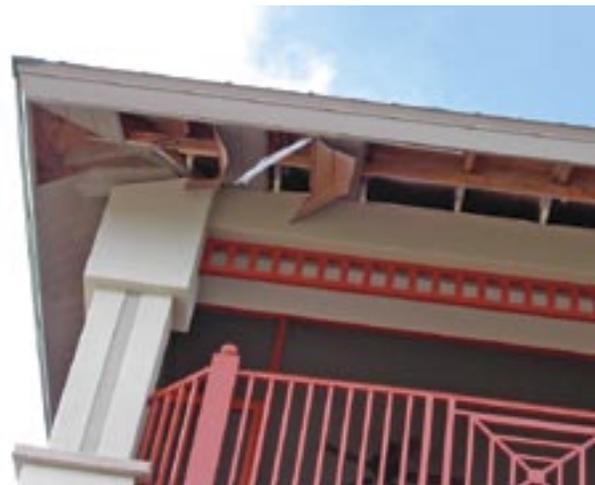
Soffit damage on the third story of a multi-family building. (Captiva Island)

Soffit failure led to many instances of significant damage to building interiors.

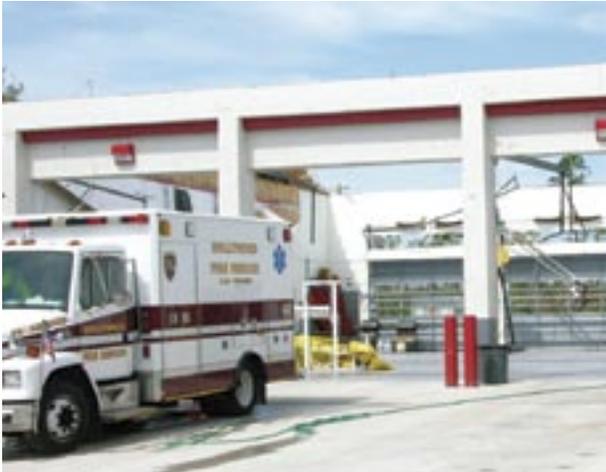
Failure of three of six new doors on a fire station in Charlotte County resulted in the loss of the entire roof structure over the apparatus bay during Hurricane Charley.

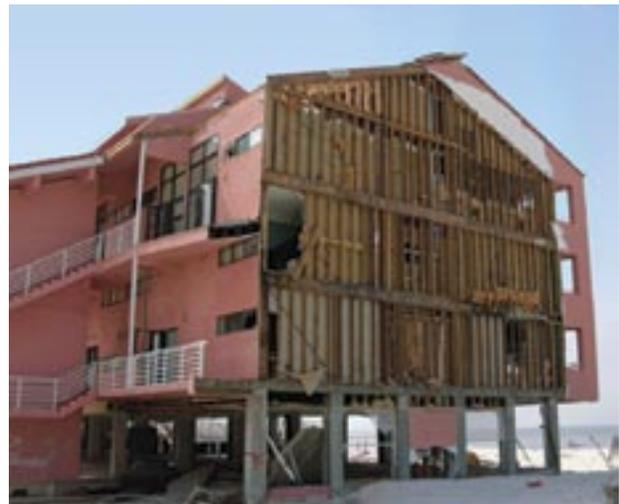
Example of wall cladding failure. The building had synthetic stucco installed over molded, expanded polystyrene insulation and gypsum board. The gypsum board blew off during Hurricane Ivan.

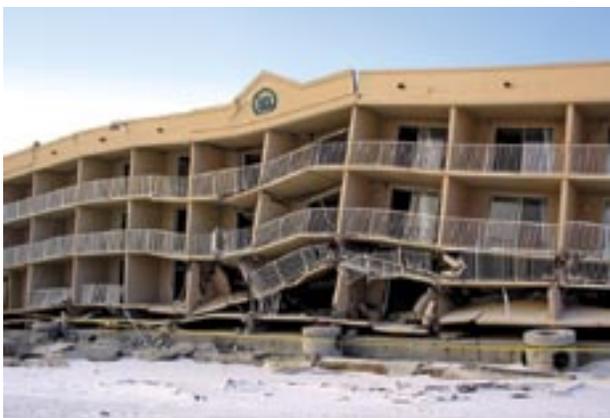
A multi-family condominium collapsed after Hurricane Ivan due to erosion of supporting soil under the shallow foundation.

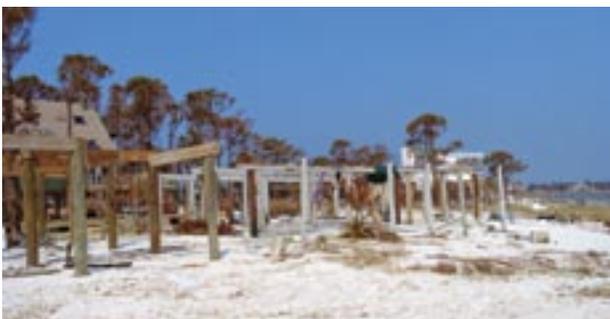
Several structures were completely torn off their pile foundations during Hurricane Ivan as a result of significant flood depths, waterborne debris impacts, and lack of connections.

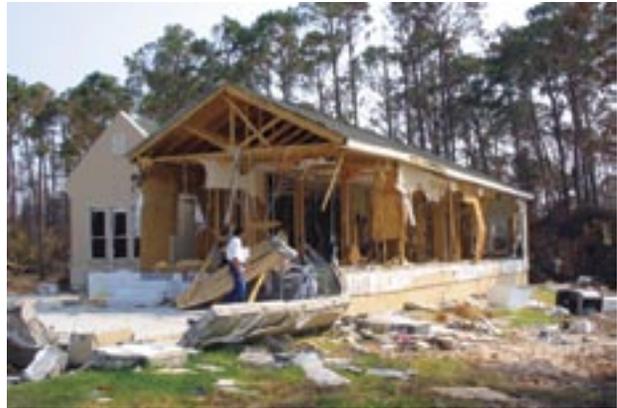
Flood water from Hurricane Ivan exceeded the required elevation of the top of the lowest floor supported by the stem wall foundation for this house leading to severe damage caused by waves and debris impact.

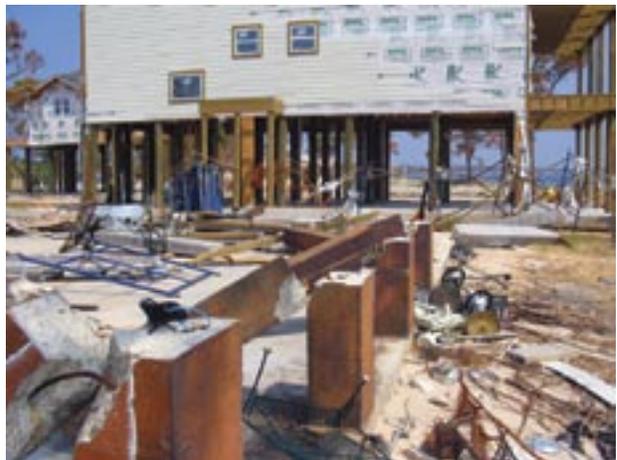
High flood levels during Hurricane Ivan and lack of structural capacity to withstand waves and debris loads caused this reinforced pier foundation to fail.

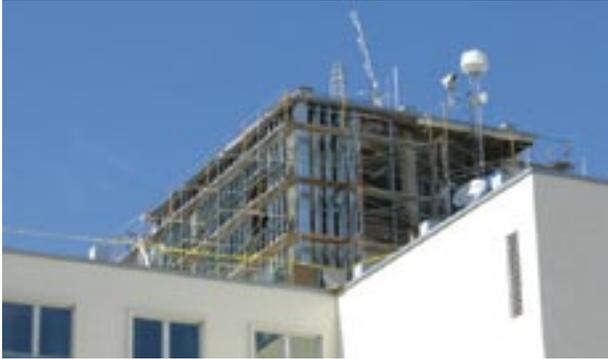
At the Martin Memorial Hospital (Pensacola, Florida) wall panels blew off the elevator penthouse during Hurricane Frances. Rain water entered the elevator equipment room damaging much of the equipment. The falling panels punctured the main roof and at least one of the lower roofs. Because of rain water infiltration and lack of elevator service, floors 2 through 6, which contained 75% of the hospital's beds, were inoperative. Many patients were relocated to other hospitals until the penthouse walls were re-sheathed and new elevator equipment was installed.

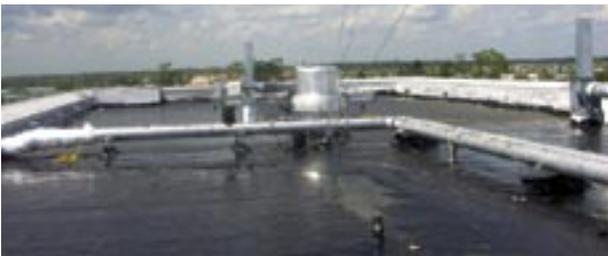
An emergency roof (shown) was installed after Hurricane Charley blew the mechanically attached PVC membrane roof covering off the concrete deck of the Fawcett Memorial Hospital.

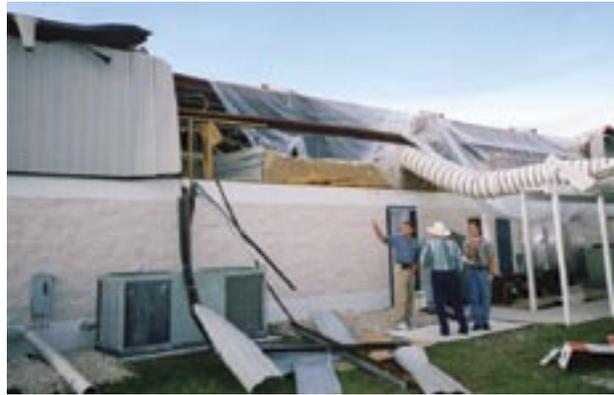
The Charlotte County Sheriff's Office/County EOC, located in a pre-engineered metal building, was significantly damaged and completely taken offline. Despite having openings protected with shutters, the building failed by loss of roof panels (failure of roof clips) and loss of metal wall panels. These failures allowed damaging amounts of rain and debris to enter the facility resulting in closure of the building. The county was aware of the weakness of this facility, and prior to Charley, had begun the design process for a new county EOC facility that would meet statewide Enhanced Hurricane Protection Areas (EHPA) requirements and guidelines not used in the design of the existing structure.

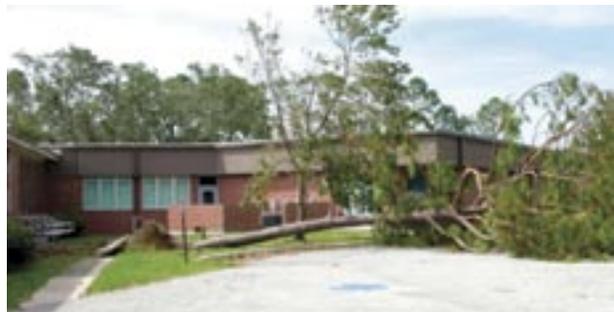
This school building experienced several building envelope problems, which allowed water intrusion, but it did not disrupt operations. Damage and disruptions may have been worse if design wind speed conditions had been experienced.
